ST HELENA AIRPORT
HLE-1600-1627-EN-RPT-0025

ANNUAL ENVIRONMENTAL REPORT FOR ST HELENA AIRPORT

ANNUAL ENVIRONMENTAL REPORT FOR THE ST HELENA AIRPORT 2020 - 2021

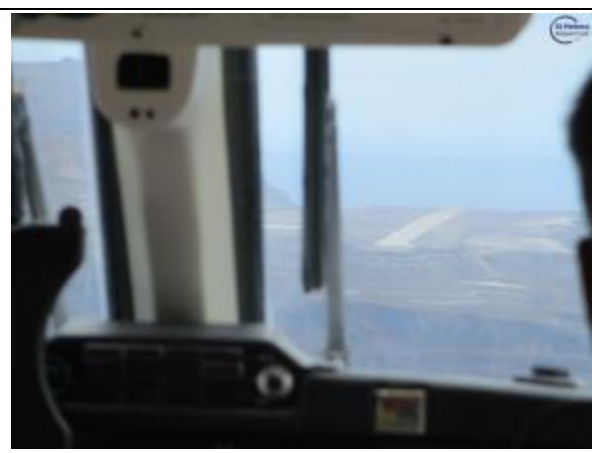
Plate 6: View of Runway 02 from the cockpit of the Beechcraft Super King Air during flight calibration testing

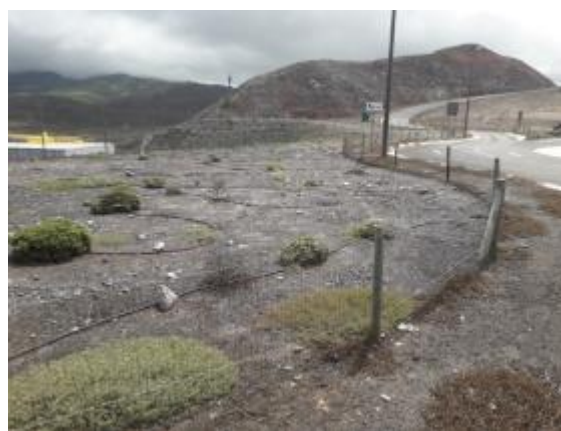
Plate 21: The STP bed with some thriving Scrubwoods (left of photo) and self-sown Saltbush (foreground and right of photo)

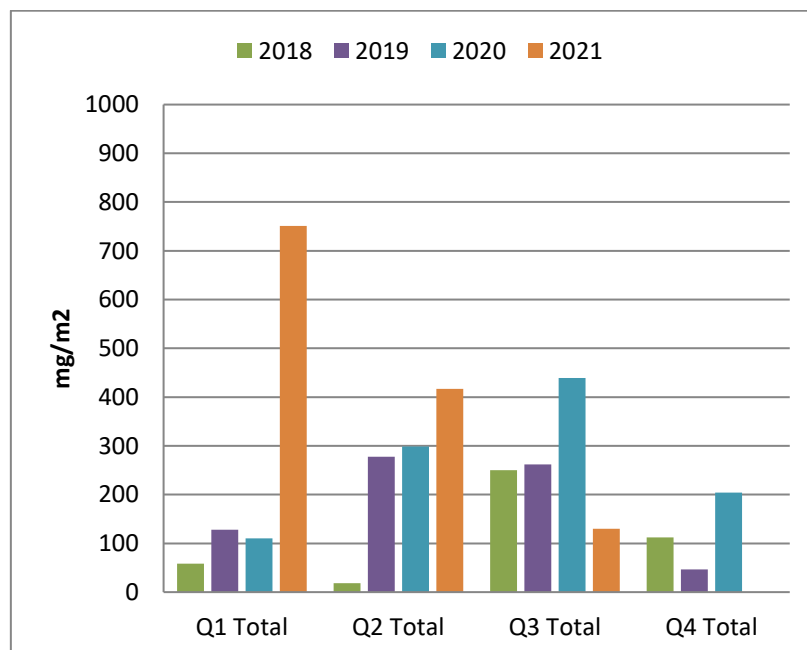
Figure 11: Quarterly average dust measurements for bucket 1

As might be expected, there is more dust in the bucket nearest to the runway (bucket 2) than in bucket 1 (compare Figures 11 and 12). There was a lot more dust than normal in the first quarter of 2021 due to the above average hot and dry conditions, but the quantity collected decreased as the year progressed with the onset of wetter weather.

In spite of the increase in dust fall out in buckets 1 and 2 during Q1, the figures shown are per quarter and are thus all well within the maximum allowed, which is 600 mg/m²/day.

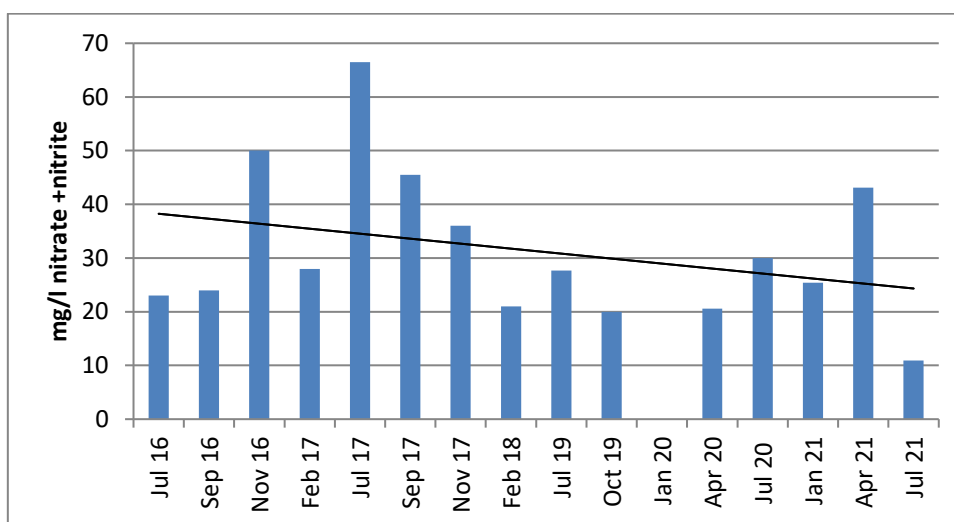
Figure 13: Nitrate plus nitrite concentrations in the STP effluent

Samples of the STP effluent are supposed to be analysed on a quarterly basis by the Hospital laboratory, but only three sets of samples were tested during the reporting period. The samples were analysed for the following parameters: nitrate plus nitrite, phosphate, electrical conductivity, pH, copper, iron and manganese in order to check the effluent against the EMS standards. At this point in time, the Hospital laboratory does not have the analytical capacity to monitor other key elements such as ammonia, chemical oxygen demand and biological oxygen demand, which would typically be monitored in STP effluent.

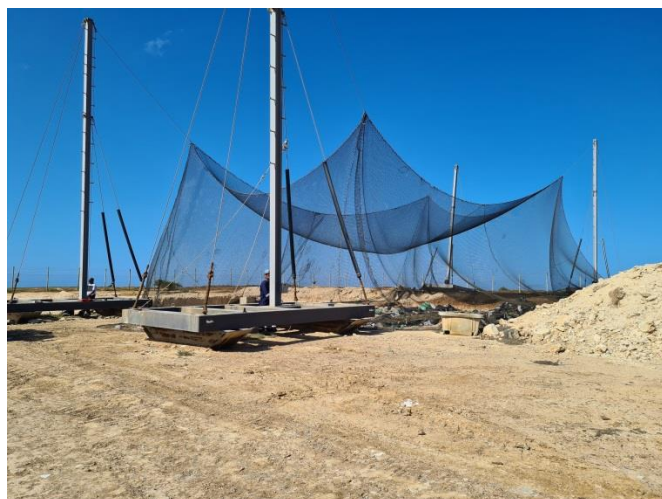
Plate 24: Maintenance on the bird netting at the HPLS domestic waste dump

There is a comprehensive system of waste management in place at the Airport which has to comply with the Waste Management Plan contained in the EMS. All wastes are separated according to whether they are hazardous or not and by type, where relevant. The wastes are collected in colour-coded wheelie bins in special temporary waste storage areas, with one outside the Terminal Building and another by the Security Gate for all airside wastes. Hazardous wastes are taken to the hazardous waste cell at Horse Point Landfill Site (HPLS) by the EO, while non-hazardous wastes are collected by EMD on a weekly basis for disposal in the netted domestic cell at HPLS (Plate 24).

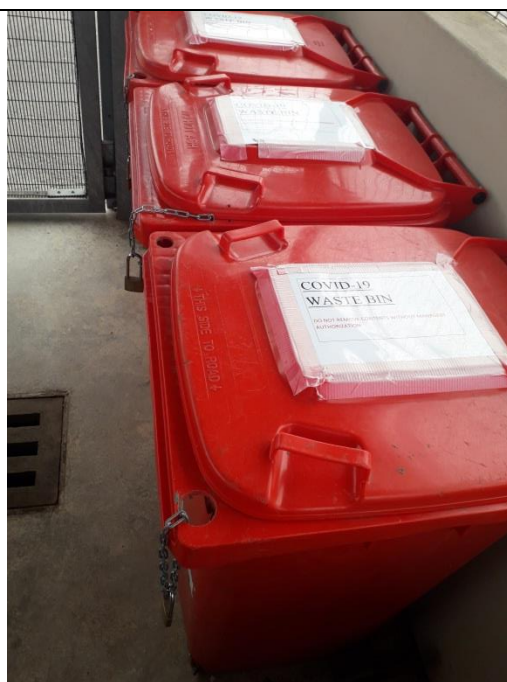
Plate 25: Special, locked disposal containers for Covid-19 waste

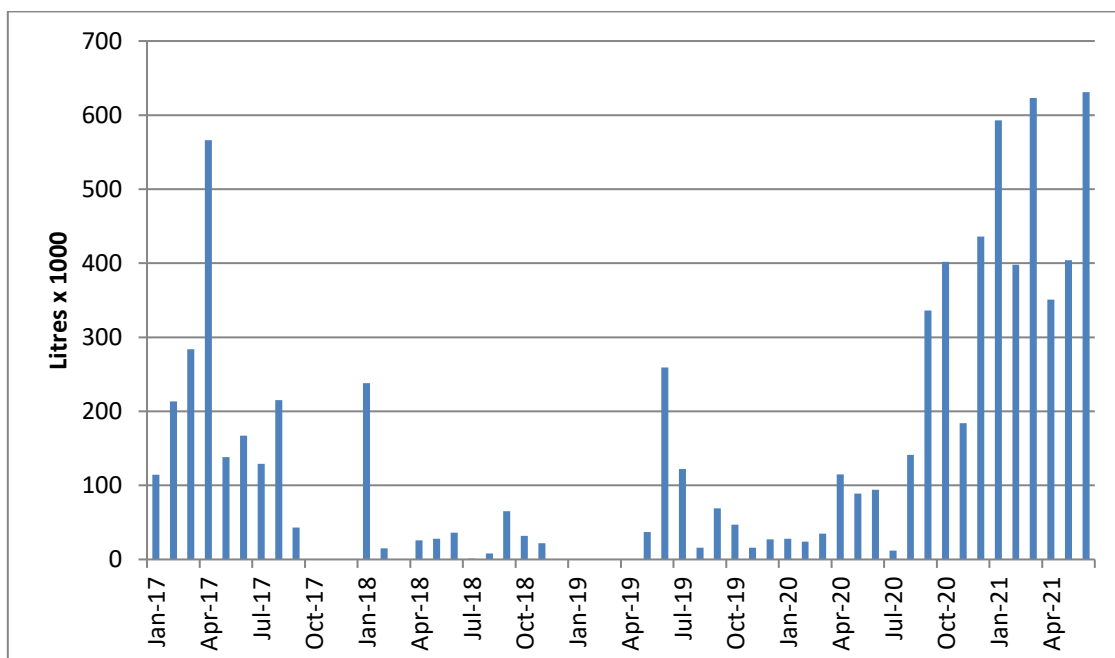
Figure 21: Monthly treated water consumption at the airport

has meant erratic and high usage at times (Figure 21). SHAL is liaising with Connect to move the water meter from its current position at Bradleys to the airport fence so that only actual airport consumption is metered and paid for, but resolution of this issue is also being held up by the dispute over ownership of the water supply infrastructure to the airport (between SHG and Connect).

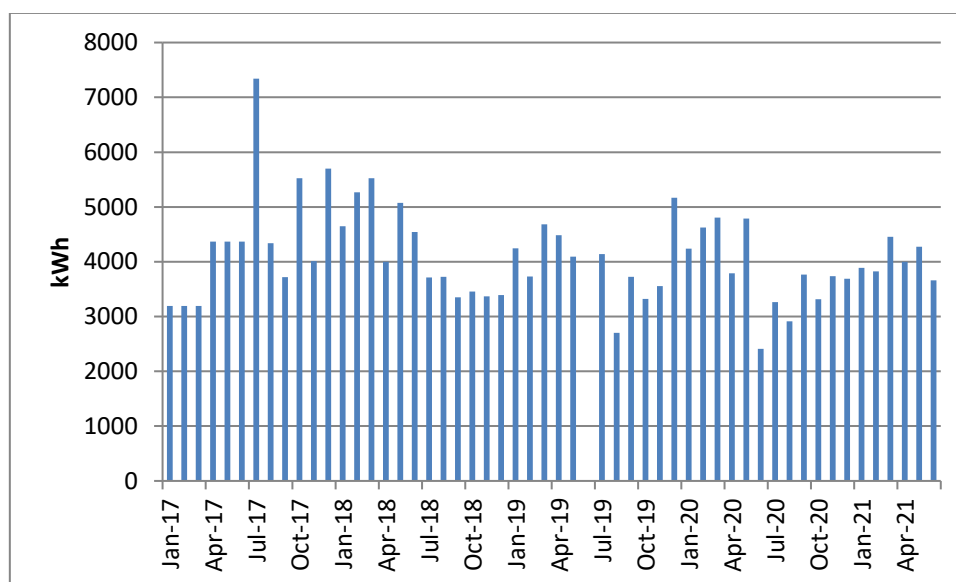
Figure 23: Monthly energy consumption

The total energy use during the year was 44,790 kWh, compared to 47,268 kWh in 2019-20, which is a slight decrease due to the reduced number of flights and passengers during the reporting period (Figures 22 and 23). A number of measures to reduce power consumption have been taken such as turning off electrical equipment when not in use e.g. air conditioning units, and replacing light bulbs with LEDs where possible. These measures, and others to be implemented when the budget allows, are all part of the efforts to improve energy conservation and obtain Level 2 ACI certification (see s. 3.3).

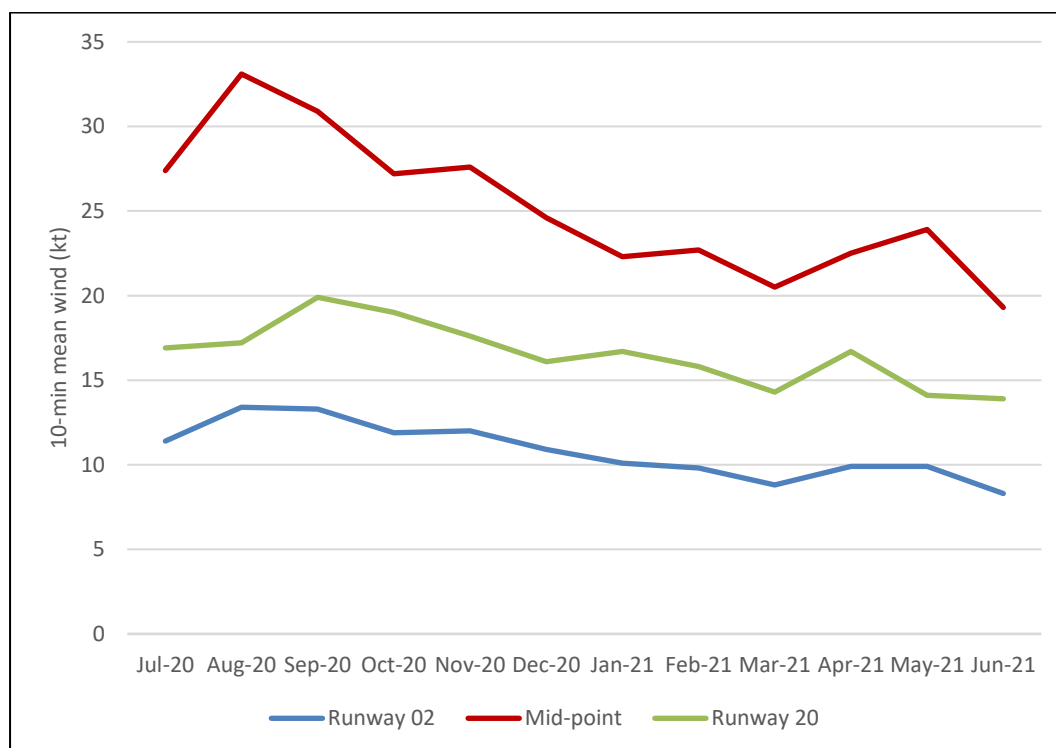
Figure 32: Monthly average 10-minute wind speed at monitoring points along the runway

The Island lies in the south-east trade wind belt and with no other land for thousands of kilometres, the south-easterly winds are constant and strong from year to year, averaging around 16.1 knots at the northern end of the runway (runway 20), 24.9 knots at the runway mid-point and 10.6 knots at the southern end (runway 02) (Figure 32). Monthly average wind speed does, however, vary slightly with the seasons, with the winter months of June to October being noticeably windier than the summer months (Figure 32).

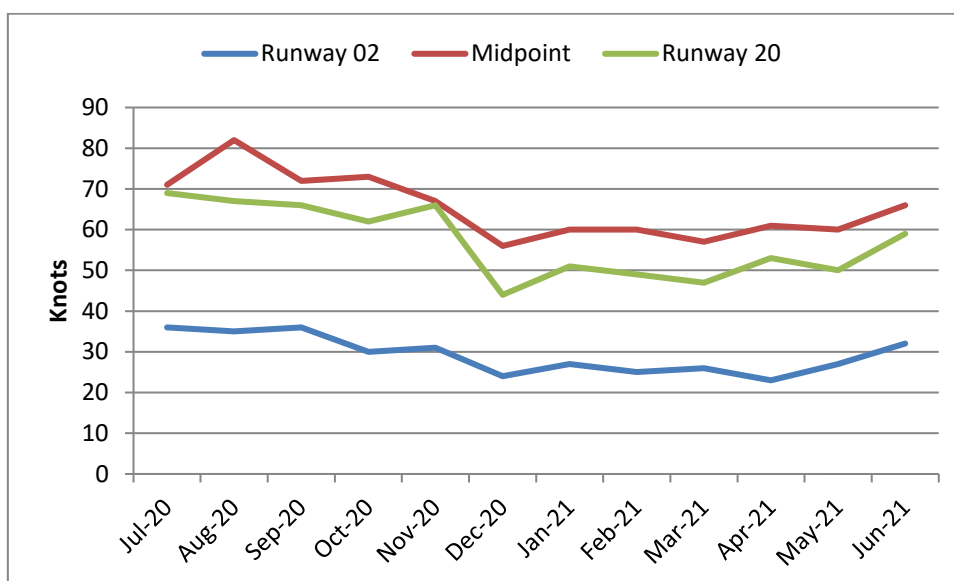
Figure 33: Maximum gust at monitoring points along the runway

There are few calm days, and very strong gusts of between 30 and 70 knots are common (Figure 33), with the highest sustained gust over 10 minutes recorded to date being 86 knots in August 2018. The strongest winds tend to occur in late winter (August-September or 'Scruffy August') and the third highest gust on record (82 knots) also occurred in August 2020. The average maximum gust speeds for the reporting period were 29.3 knots on Runway 02, 65.4 knots (Mid-point) and 56.9 knots on Runway 20 (Figure 33).

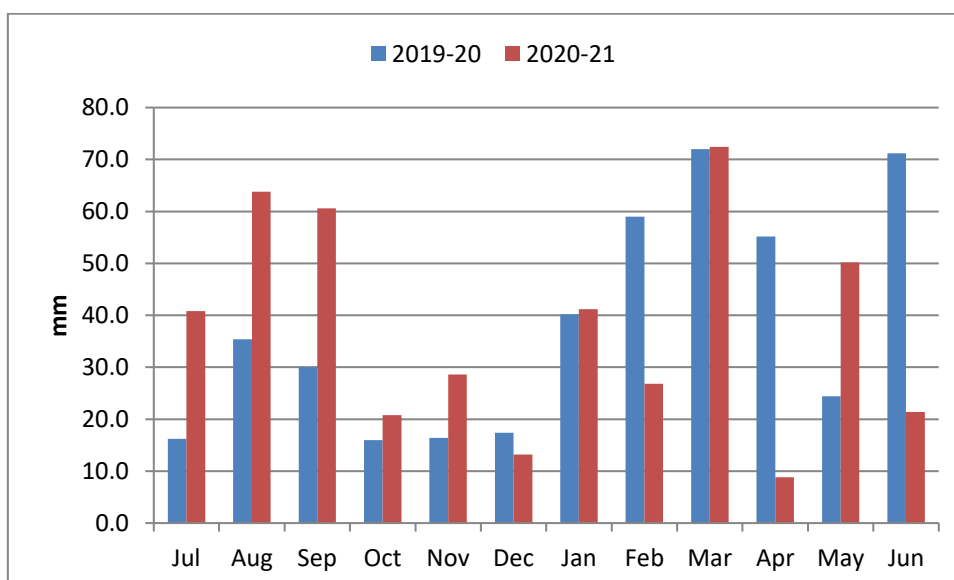
Figure 34: Monthly rainfall at the Bottom Woods Met Station 2020-21

The average annual rainfall at the Bottom Woods Met Station for the period 2001-20 is 514.6 mm, ranging from over 730 mm in 2008 to a low of 286 mm in 2019. In 2020, the annual rainfall was 549.8 mm, which exceeds the average, but the first half of 2021 was much drier, experiencing about 100 mm less than for the same period in the previous year (Figure 34).

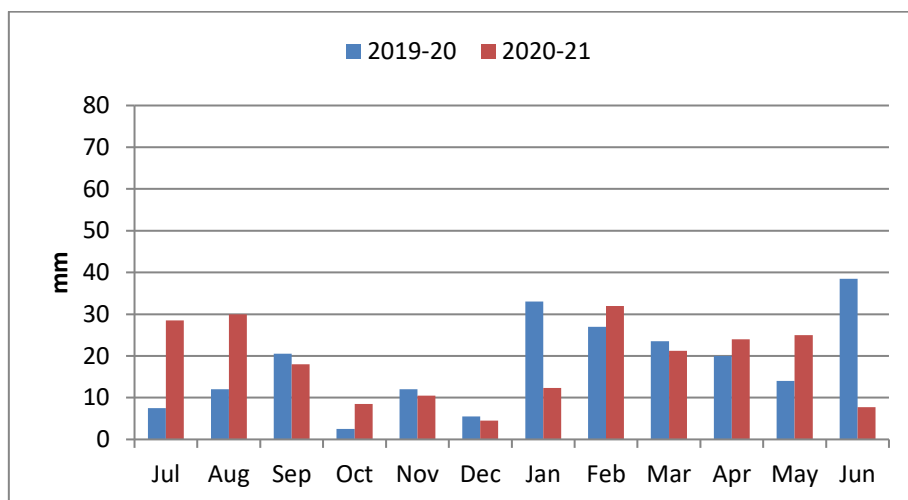
Figure 35: Monthly rainfall at the Airport precinct 2020-21

By contrast, the average annual rainfall at the airport precinct over the 4-year period of record is about half of the Bottom Woods total at 263 mm (Figure 35). The annual rainfall at the precinct in 2020 was 256 mm which is close to the average, but the first half of 2021 was also much drier than usual (Figure 35).

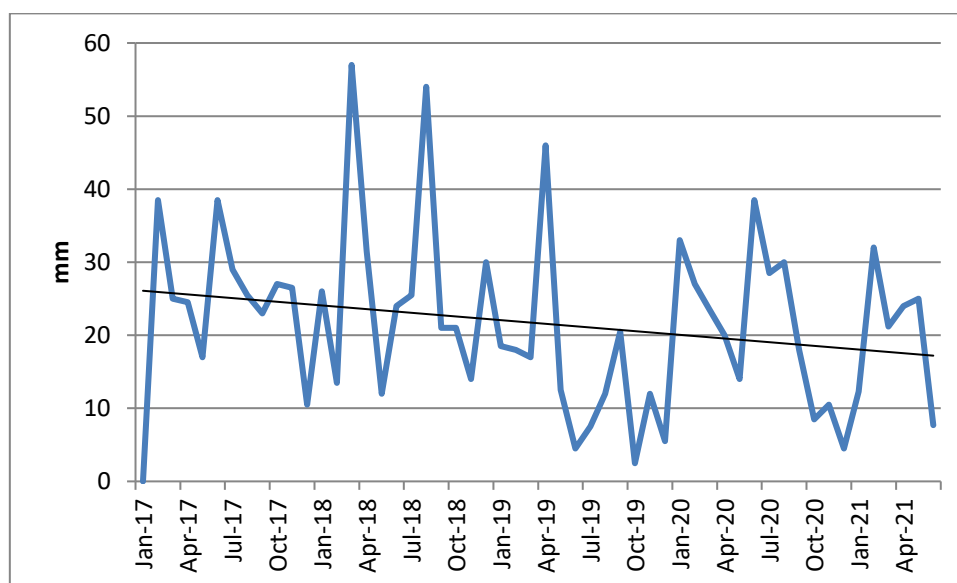
Figure 36: Mean monthly rainfall at Airport precinct 2017-21

The monthly rainfall pattern shows a distinct difference between the drier spring and summer months (October to January) and the wetter autumn and winter months (Figure 36). However, there is a noticeable decrease in rainfall over the past four years as seen in the trend line in Figure 36. The period of record is too short to determine if this is due to climate change or part of a natural cycle.
