# ENVIRONMENTAL MANAGEMENT SYSTEM FOR ST HELENA AIRPORT

## ANNUAL ENVIRONMENTAL REPORT: 2018-2019

## **ANNUAL ENVIRONMENTAL REPORT FOR THE ST HELENA AIRPORT 2018 - 2019**

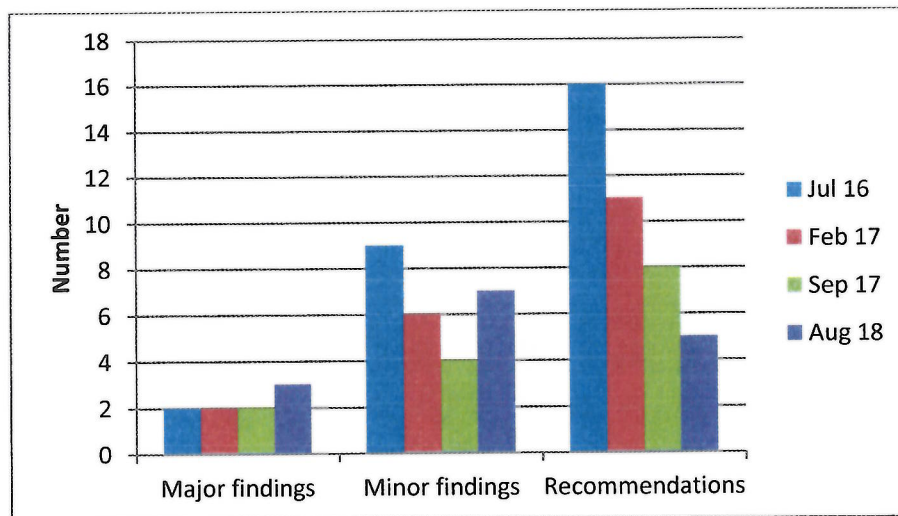
**Figure 7: Audit findings**

The EMS specifies that an environmental audit of airport operations should take place on an annual basis. The annual audit was carried out by the Airport's Environmental Consultant in August 2018. It can be seen from Figure 7 below that there was a slight increase in the number of major and minor findings over the previous year, but the number of recommended actions has decreased.

The one major issue identified in all the audits to date relates to the quality of the effluent being discharged from the sewage treatment plant (STP). This has been an ongoing issue and is being closely monitored. The problem appears to be caused by the fact that the STP was designed for a certain through flow from the predicted number of people passing through the airport on a weekly basis with commercial flights in operation. Even though commercial flights have commenced, the number of passengers is lower than that originally envisaged, due to the smaller plane being used by Airlink. Thus the through flow is less than the design specification for the plant to function at optimal levels. See section 7.2.2 for more information on this matter.

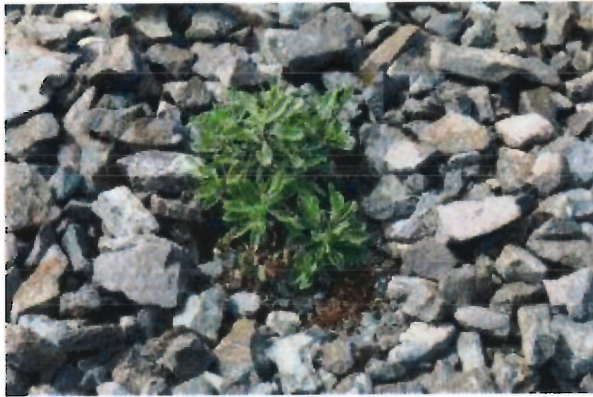
In May 2018, twelve scrubwoods were planted in the gravel in front of the Terminal Building to improve the aesthetics of this area, however they were not protected from rabbits and in November 2018, it was reported that all the plants had been destroyed by rabbits (Plates 7 and 8).

**Plate 7: One of the scrubwoods planted in the gravel in front of the Terminal Building in August, 2018 (Photo: B Walmsley)**

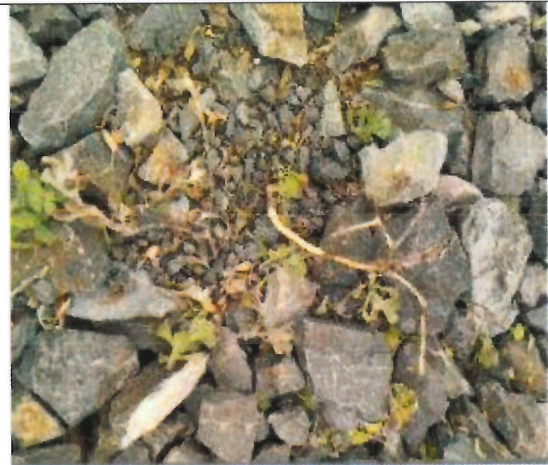
**Plate 8: A scrubwood plant following rabbit predation in November 2018 (Photo: SHAL)**

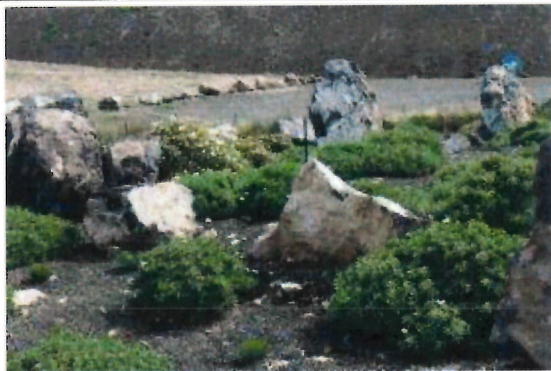
The precinct beds near the car parks were flourishing in August 2018 and as planned, it was decided to start removing the rabbit-proof fences as the plants were deemed to be mature enough to withstand light rabbit grazing (Plates 9 and 10). Sadly, with the shortage of food due to the drought, the rabbits have inflicted severe damage on many of the plants in the precinct beds as shown in Plates 11 and 12. Unfortunately, no monitoring of the plants growing in the precinct beds was undertaken during the reporting period and therefore the number of plants lost due to drought and predation is not known.

**Plate 9: Precinct garden with rabbit fence removed showing healthy, mature scrubwoods and St Helena ebonies in August 2018 (Photo: B Walmsley)**

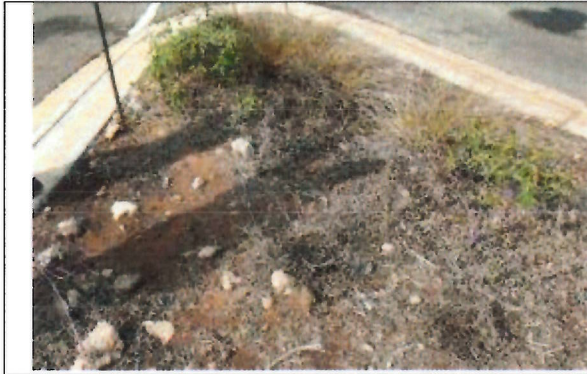
**Plate 11: Extensive rabbit damage to scrubwoods**  
(Photo: B Walmsley)

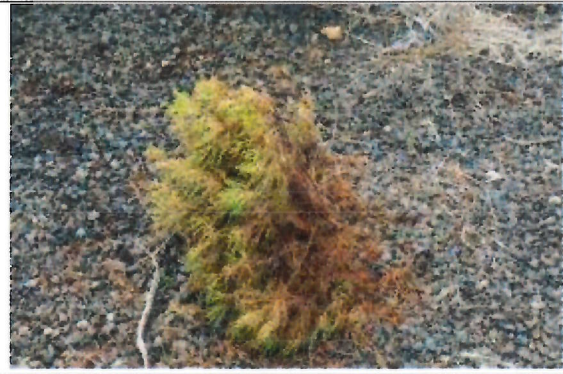
**Plate 12: The protective cage around this tea plant had blown away and the plant has been eaten by rabbits** (Photo: B Walmsley)

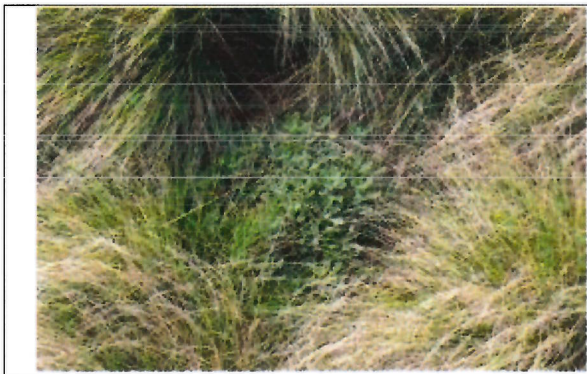
In addition, the lack of a clear definition of responsibilities for maintaining the beds resulted in species such as hair grass and thatching grass smothering some other less aggressive species such as the ebonies and scrubwoods (Plate 13). Furthermore, the shortage of water was having a visible effect on the St Helena ebonies (Plate 14).

**Plate 13: Hair grass smothering a young, self-sown scrubwood** (Photo: B Walmsley)

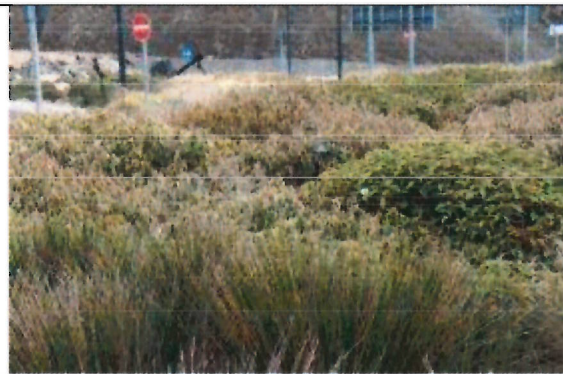
**Plate 14: Wilting ebonies due to water stress during the drought** (Photo: B Walmsley)

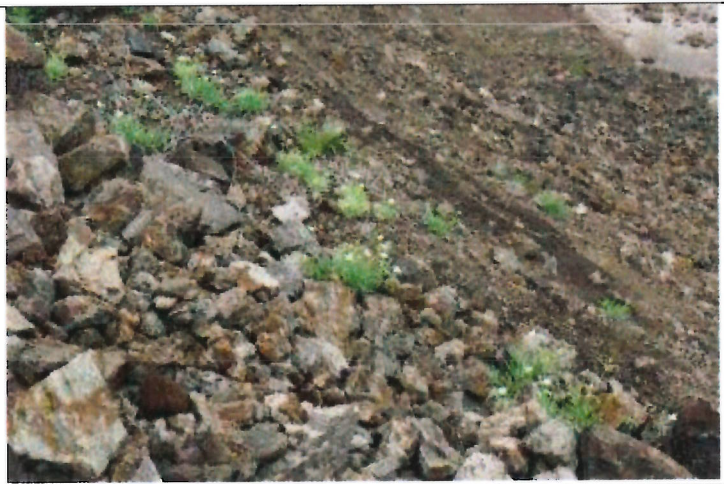
During the August 2018 audit, several self-sown salad plants (*Hypertelis acida*) were observed to be growing on the Dry Gut fill next to the track leading down into the open channel (Plate 17), but it is feared that these were later eaten by rabbits. Also during August, between 5 and 8 self-sown scrubwoods (*Commidendron rugosum*) were observed growing near some mature plants on King and Queen Rocks (Plate 18).

**Plate 17: Self-sown salad plants on the Dry Gut fill** (Photo: B Walmsley)

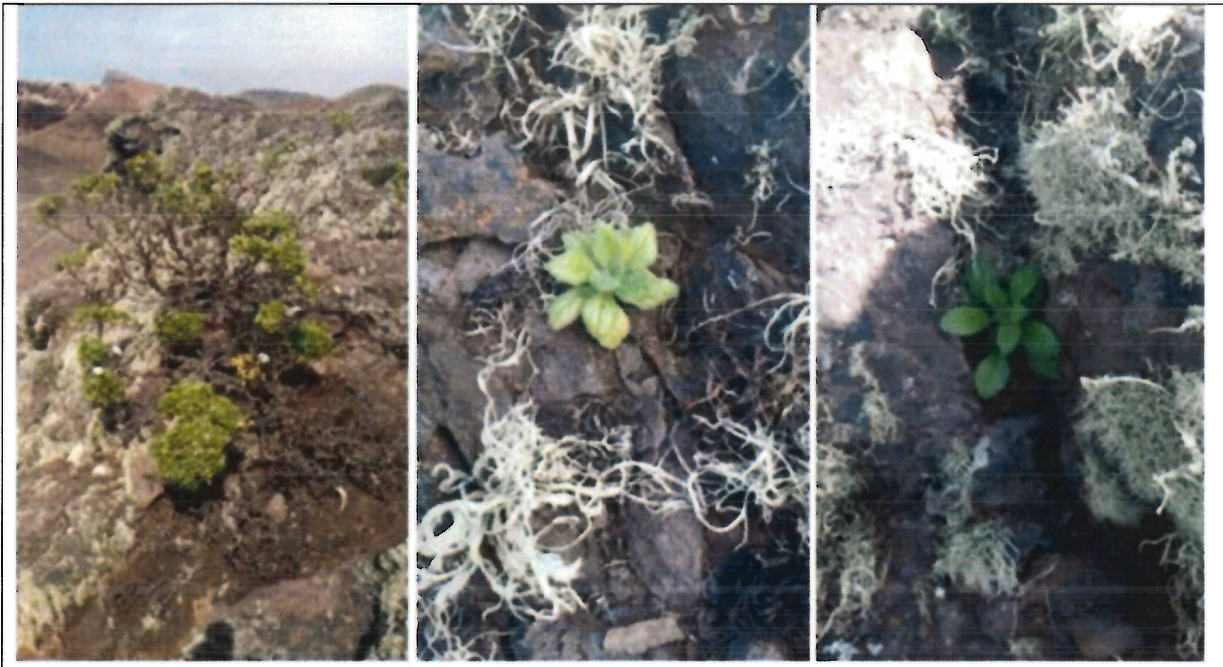
**Plate 18: Scrubwoods growing near King and Queen Rocks with some self-sown plants in the surrounding area (Photo: RFFS)**

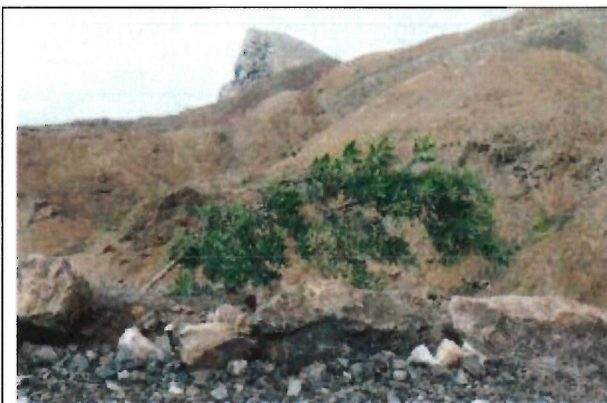
It was also noted during the August 2018 audit that there are some woody species e.g. wild tobacco (*Nicotiana glauca*) and wild mango (*Schinus terebinthifolius*) growing in the Dry Gut fill which is not desirable as their root systems could cause preferential flow of water and subsequent piping, which could affect the engineering integrity of the structure (Plates 19 and 20).

**Plate 19: Wild tobacco growing in the Dry Gut fill (Photo: B Walmsley)**

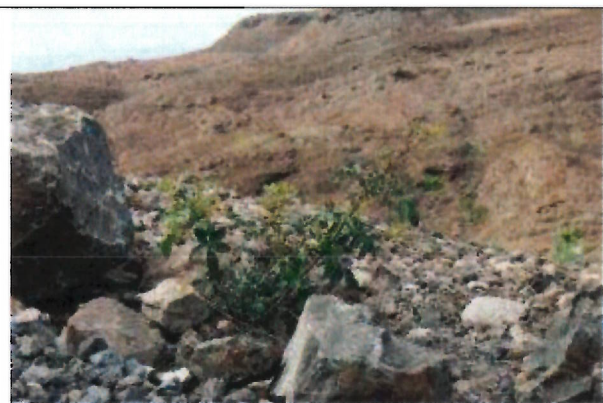
**Plate 20: A wild mango plant growing in the Dry Gut fill (Photo: B Walmsley)**

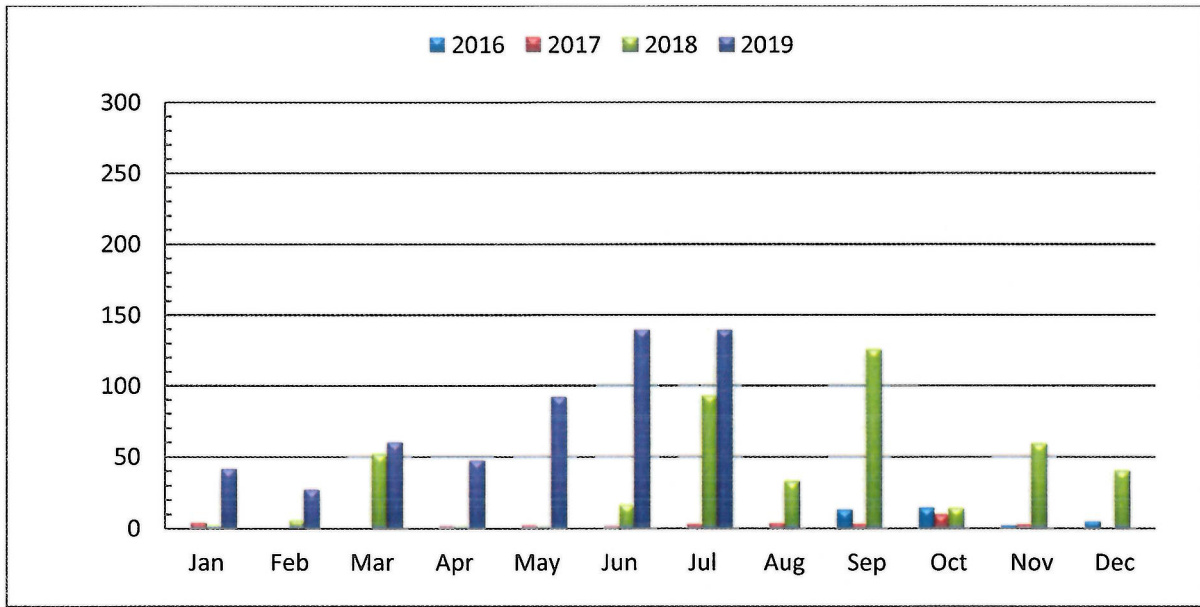
**Figure 8: Monthly average dust measurements for bucket 1**

an average of 160 mg/m<sup>2</sup>/d was recorded compared to last year's average of 8.03 mg/m<sup>2</sup>/d (see Figures 8 and 9). Dust bucket 2 is located about 150 m from the centreline of the runway and dust bucket 1 lies about 300 m away and at a slightly lower elevation. This explains the significant difference in the amount of dust recorded in bucket 2 (closest) compared to bucket 1 (further away).

In spite of the significant increases, these totals are well below the limit prescribed in the EMS of 600 mg/m<sup>2</sup>/d. The increases can be ascribed to the exceptionally hot, dry, windy conditions and below-average rainfall over the past year (see also s. 7.2.8), with peak dust fall occurring in winter with the stronger wind conditions (Plate 21). There was also an increase in dust following the removal of the

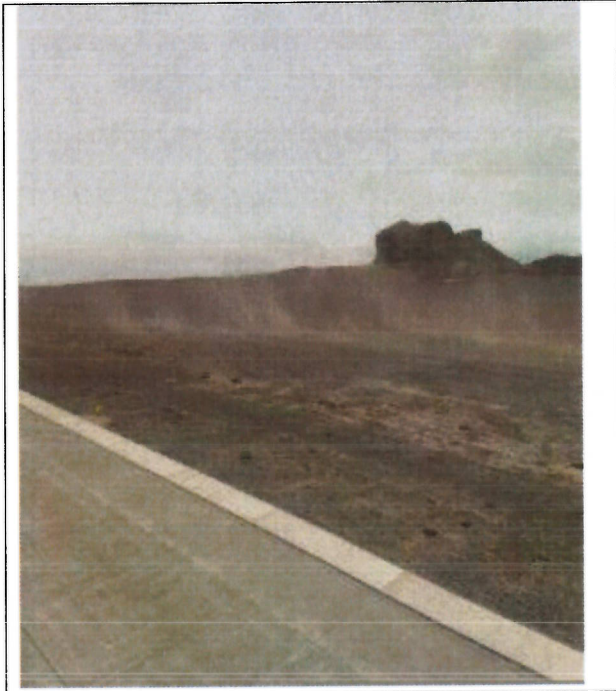
Plate 21: Dust blowing alongside runway 20 on 30/10/18 (Photo: SHAL)

saltbush plants from the airfield in January (see s. 7.2.3 and 7.2.7 below). This underlines the importance of promoting the growth of vegetation on the airfield to reduce the amount of dust, but not plants that attract birds.

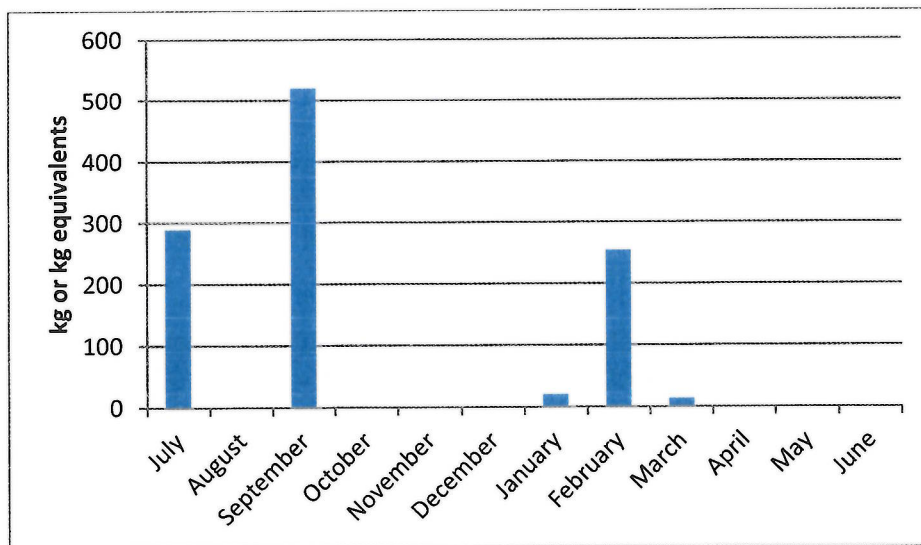
Figure 10: Hazardous waste production per month, 2018-19

The amount of hazardous waste produced was significantly higher this year than the previous year at 1,096 kg compared to the 64 kg (or kg equivalents) of waste generated in the last reporting period. This was largely due to workshop wastes, such as oil, oil filters and oily rags, from servicing the airport ground equipment (September) and the back-up generators in February (Figure 10). Other small quantities of hazardous wastes produced at the airport include fluorescent light fittings, batteries and galley wastes from charter aircraft.

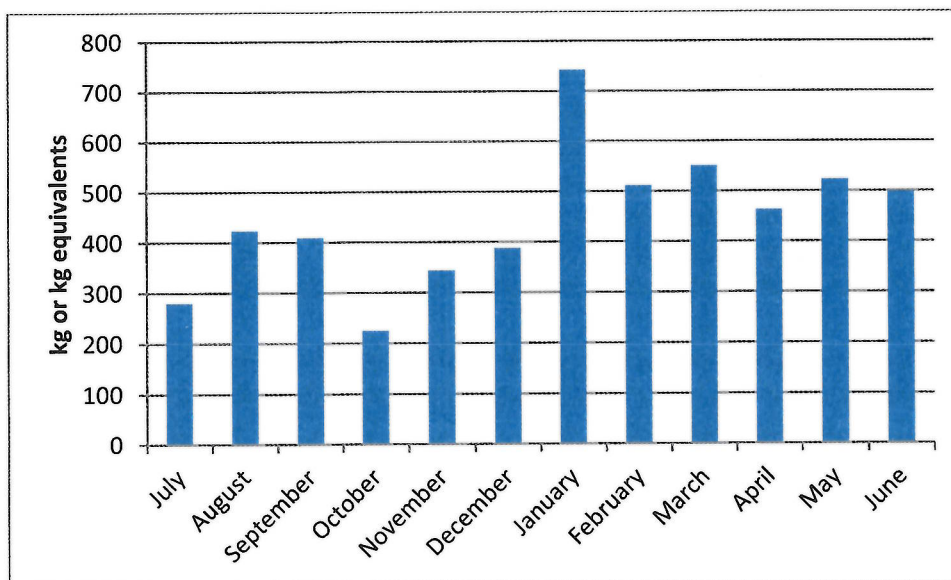
Figure 11: Non-hazardous waste produced per month, 2018-19

As expected, the amount of non-hazardous waste has increased this year due to the introduction of the additional weekly flight for 5 months over the summer months (Figure 11). A total of 5,345 kg (or kg equivalents) of non-hazardous waste was produced (compared to 3,602 kg last year). Most of this waste is general waste from the Combined and Terminal Buildings, with minor amounts of paper/cardboard packaging, scrap metal, tyres, etc. The airport generates on average 445 kg of non-hazardous waste per month.

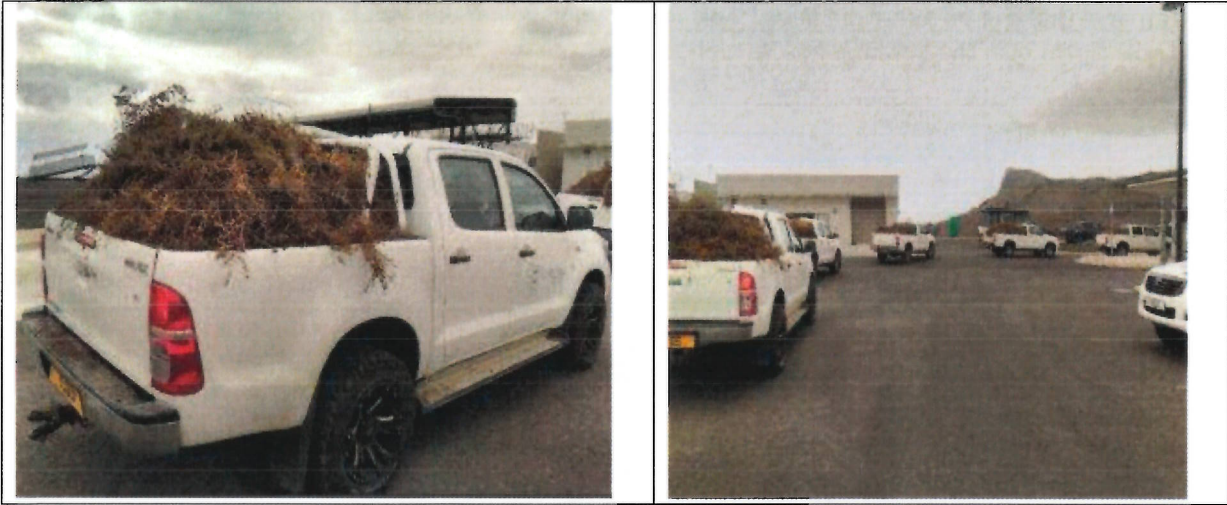
In addition, the self-sown common saltbush plants (*Atriplex semibaccata*) growing all over the airfield had to be pulled out and disposed of because the berries were attracting pigeons to the airfield which is not desirable from a bird strike risk point of view. A total of 26,970 kg of this plant was removed in January and March 2019 (Plate 22).

Plate 22: Removal of more than 26,970 kg of saltbush from the airfield during January for disposal at Horse Point Landfill site

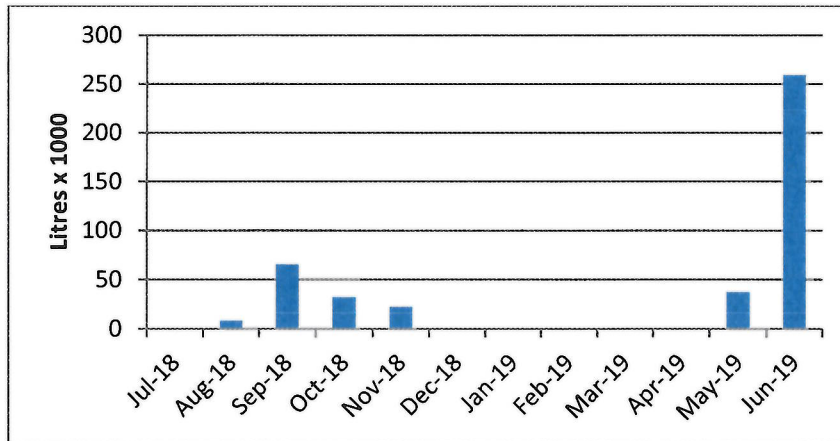
Figure 12: Monthly potable water consumption at the airport

During the reporting period, the Airport was supplied with 424,000 litres of treated water by Connect. The monthly consumption figures are shown in Figure 12, but unfortunately the water meter was broken from December to April 2019 and therefore no readings were available for these months. The excess consumption recorded in June 2019 can be ascribed to breaks in the pipeline outside the airport.

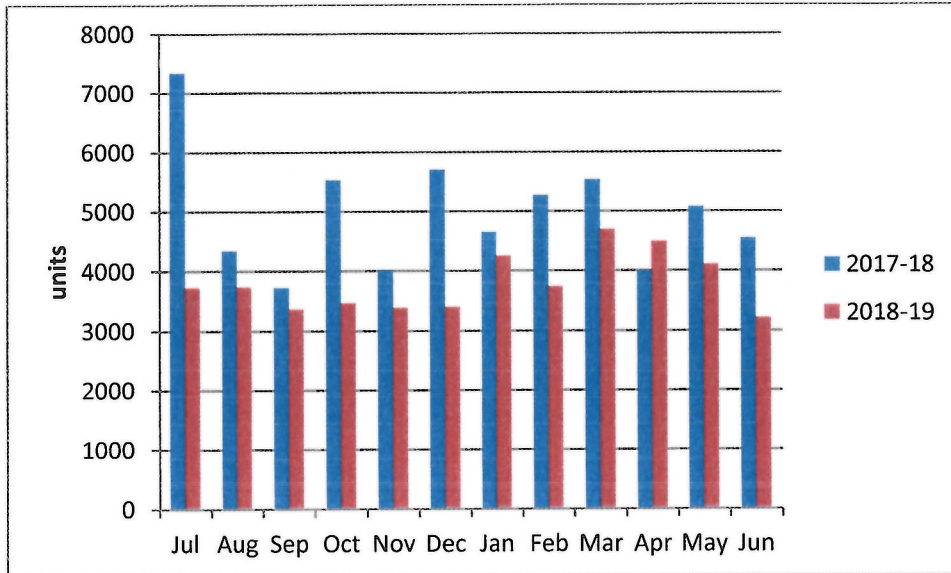
**Figure 13: Monthly energy consumption**

The total energy use during the year was 45,430 KWh compared to 59,680 KWh in 2017-18, which is a 24% reduction (Figure 13). This has been achieved by only checking and turning on the runway lights on the days of flight operations, reconfiguring the lighting systems in both the Terminal and Combined Buildings to maximise the use of daylight, and thirdly, by turning off the air conditioners in

the Terminal Building on non-flight days. This reduction in power use has also occurred in spite of the additional flights over the summer holiday period.

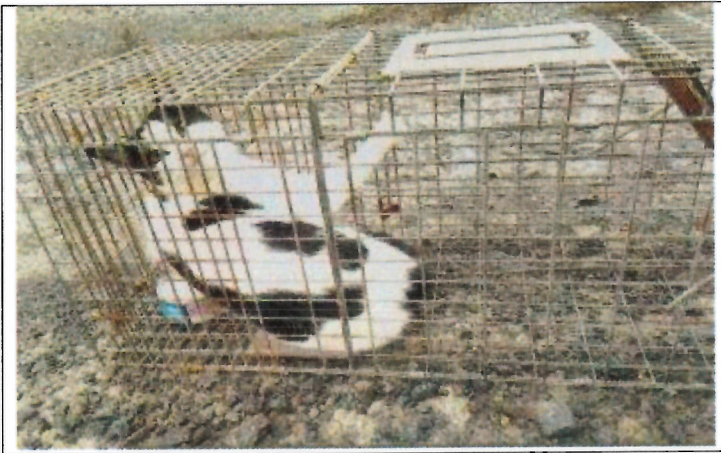
Plate 24: Feral cat caught inside the airport perimeter fence in April, 2019  
(Photo: SHAL)

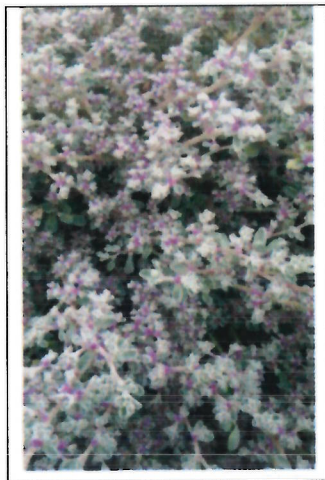
determine whether there were any viable seeds in the sand. In spite of this, individual specimens of the Namibian Ice Plant (*Galenia* spp.) started to be found in 2016 in areas which had been temporarily disturbed by construction activities, e.g. at the PBP site compound, and at the airport (Plate 25). The LEMP team together with RFFS staff carried out a search within the fenced area of the airport in September 2018 and found 234 Namibian Ice Plants, which were removed and destroyed according to the protocol in the EMS. Only one plant has been seen since (in the precinct area in April 2019). This could be because of the drought, and staff remain vigilant because this plant has a rapid life cycle, produces masses of seeds and is highly invasive.

Plate 25: Namibian Ice Plant in flower (Photo: SHAL)
